TEMPORARY EVENT FLOOR & TENT FLOOR

1.Product Categories

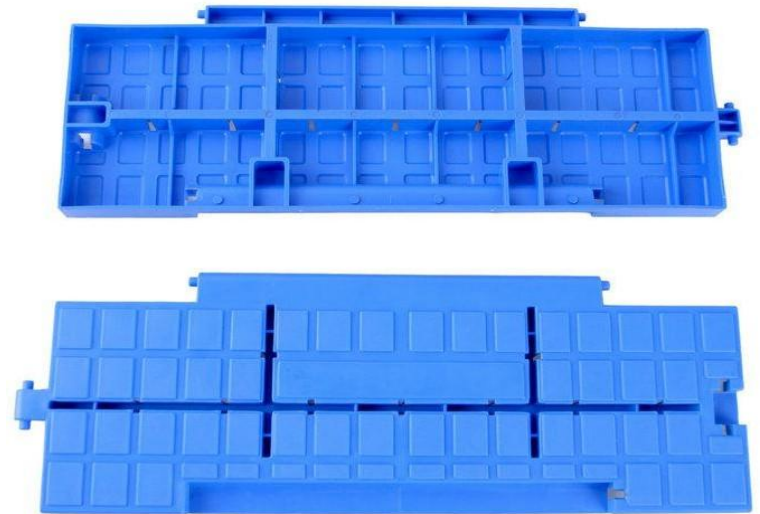
Roller Cover

- ※ Size: 30.48*10.16*1.8cm (+/-3%)
- ※ Material: High Impact PP
- ※ Weight: 110g/pc (+/-3%)
- ※ Surface: hole available
- ※ Fire Rating:UL94HB/UL 92 V-2(optional)
- ※ Color Available: Grey, blue and customized
- ※ Loading Capacity: 5 Tons/Sq.m
- ※ UV Resistance: ISO 4892:2013(E)
- ※ Connection System:Unique Rolling Design
- ※ 5 Years warranty.

- Qty/20'GP: 1350 sq.m;
- Qty/ 40HQ: 3307.5 sq.m;
